By Tarek Alkhrdaji and
Robert Charles

Renovation of Baltimore's Historic **Hippodrome** Theater

New reinforcement technology sets the stage for the future

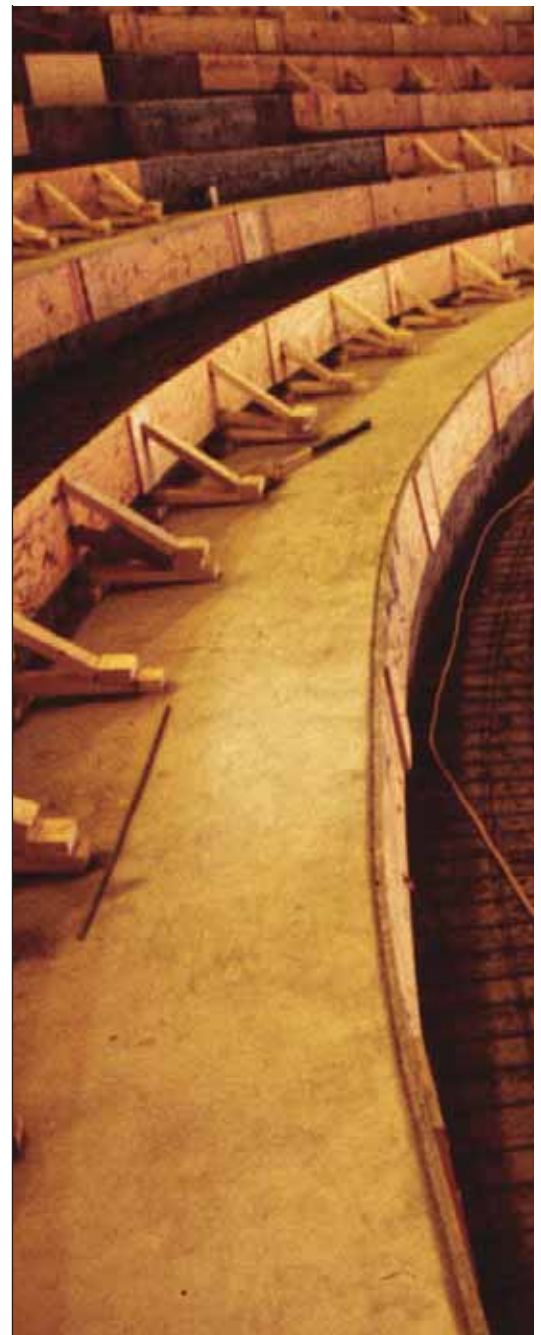
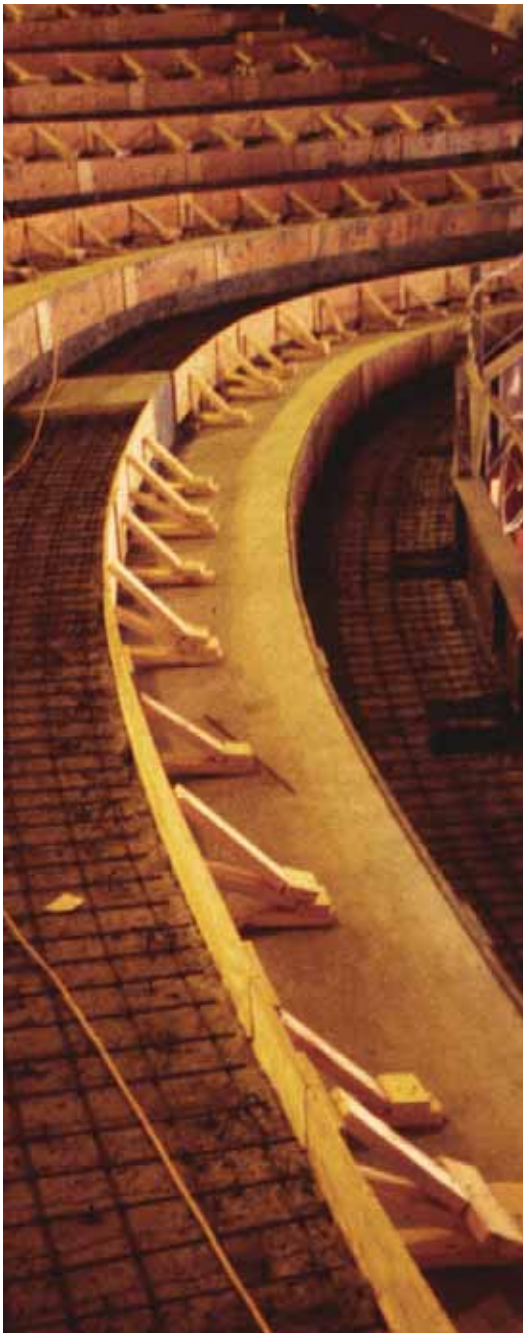
Left: Strengthening the typical 8.5-foot-span tread slab involved removing the existing slab topping and casting a 4-inch-thick bonded lightweight concrete overlay with steel reinforcement. Below: After the balcony slab was strengthened, scaffolding had to be erected on the balcony for another contractor to reach the 60-foot height needed to repair and restore damaged decorative plaster.

lightweight concrete overlay, reinforced with continuous 4x4-W7xW7 steel wire mesh or equivalent steel bars. The additional (overlaid) structural concrete slab increases the bending capacity between the supports by increasing the effective depth of the existing bottom reinforcement. At the slab supports, the embedded steel reinforcement in the overlay increases the bending capacity. Further, the reinforcement in the overlay limits cracking that could be caused by volumetric changes of the overlay (from thermal expansion/contraction or from shrinkage), thus avoiding steel corrosion and possible delamination.

The steel reinforcement was positioned at mid-depth of the overlay to provide sufficient clearance below the bars for adequate flow of concrete. Because the overlay replaced the existing topping, there was only a small increase in dead load, which was offset by using lightweight concrete. The composite behavior of the existing slab with the overlay could be taken into account only if monolithic structural action (between the overlay and the existing slab) was ensured. At the Hippodrome, adequate surface preparation achieved the needed bond.

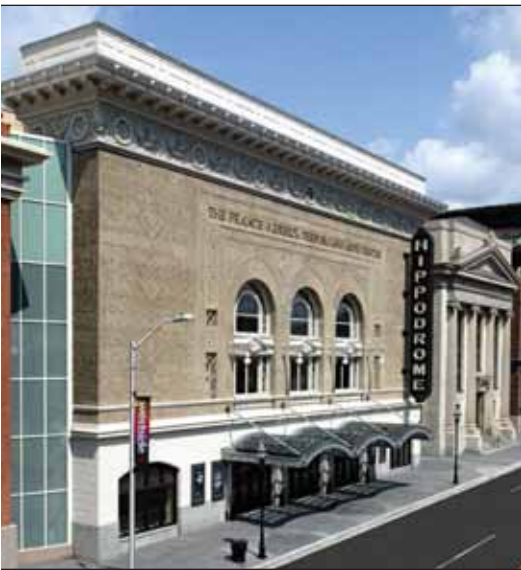
Fully restored and structurally sound, the historic Hippodrome Theater is poised to anchor a revitalized performing arts complex.

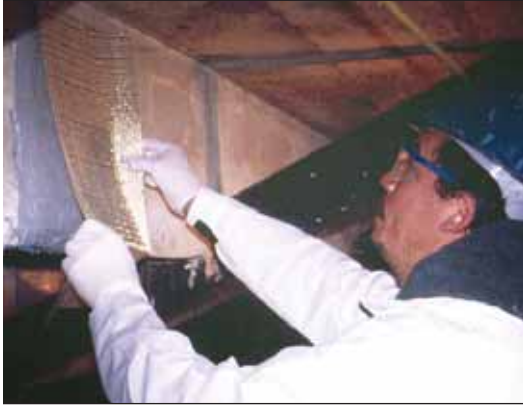
To guard against cracking due to movement under loads, Hardwire reinforcement was bonded to the back of the balcony risers with epoxy adhesive, using the wet lay-up technique.

The risers also required additional reinforcement to guard against cracking due to movement under loads. SPS used an innovative strengthening system known as Hardwire. Introduced in 2002, the Hippodrome project is the first commercial application of this technology. Similar to FRP fabric, Hardwire is a low-cost reinforcement system made of ultrahigh-strength steel wires twisted together to form reinforcing steel cords. The steel wires have a tensile strength of 450 ksi, approximately 10 times the strength of conventional structural steel, and the same elastic modulus of approximately 29,000 ksi. For this application, Hardwire was bonded to the back of the risers with epoxy adhesive using the wet lay-up technique. The Hardwire system reduces costs by using less expensive, but high-strength, material.
