# Identifying Building Envelope Problems

By Mark K. Howell

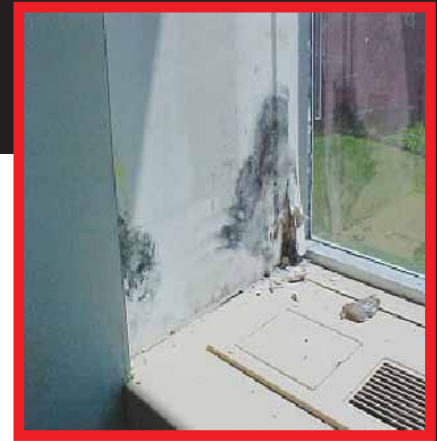
Water-damaged window soffits, jambes and sills.

- Staining of the interior wall surfaces and/or the wall system above the ceiling tiles (Figure 1)
- Water-damaged insulation above the ceiling tiles
- Stained ceiling finishes
- Water-damaged window soffits, jambes and sills (Figure 2)
- Water stains on the floor finishes, including rust stains from excessively wet steel stud base plates
- Peeling of wallpaper
- Cracking of interior finishes
- Stains / dirt in operable window tracks
- Water stains at the perimeter of the AC units
- Mold

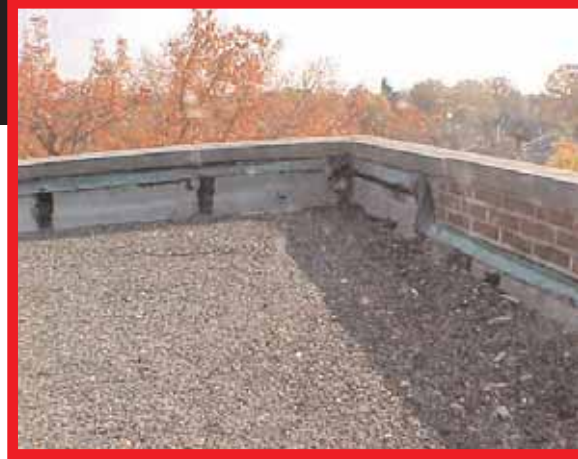
An illustration of a roof that runs up the back of a parapet wall.

- Weep holes are caulked shut
- Weep tubes or weep wicks were used
- The roof runs up the back of the parapet wall (Figure 3)
- Rust marks are present at imbedded steel locations

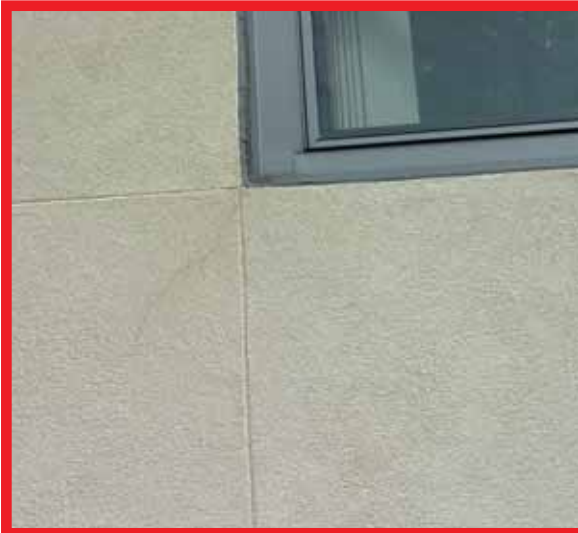
Cracking through EIFS lamina.

- Spalling brick
- Glazed brick shattered with efflorescence stains
- Cracking through EIFS lamina (Figure 4)
- Post-tensioning ends with rust bleed out
- A white haze on a brick cavity wall

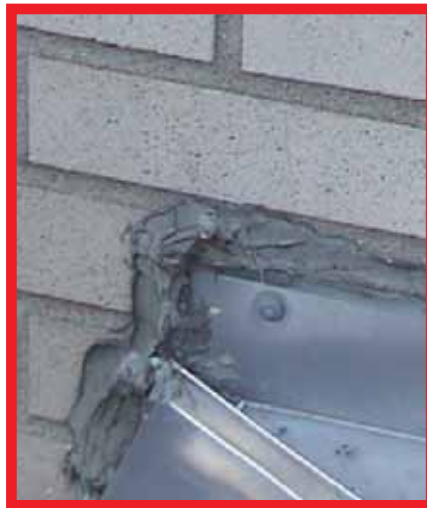
Cavity wall with roof surface-applied termination bar.

- Surface alligatoring of the roof membrane
- Roof seam splits
- Roof surface applied termination bar to a cavity wall (Figure 5)
- Overall roof drainage
- Incomplete expansion joints (Figure 6)

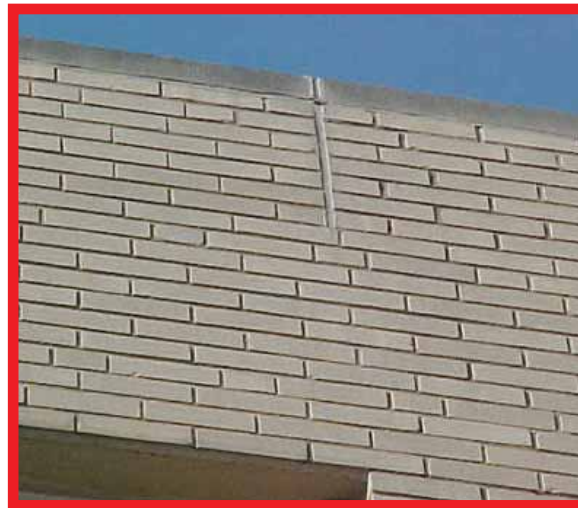
Incomplete Expansion Joints
