Miami's Freedom Tower Shines Again

A beloved architectural landmark and enduring symbol of resilience gets a last chance at rebirth—in this case, the third time's the charm

BY RANDY POWERS

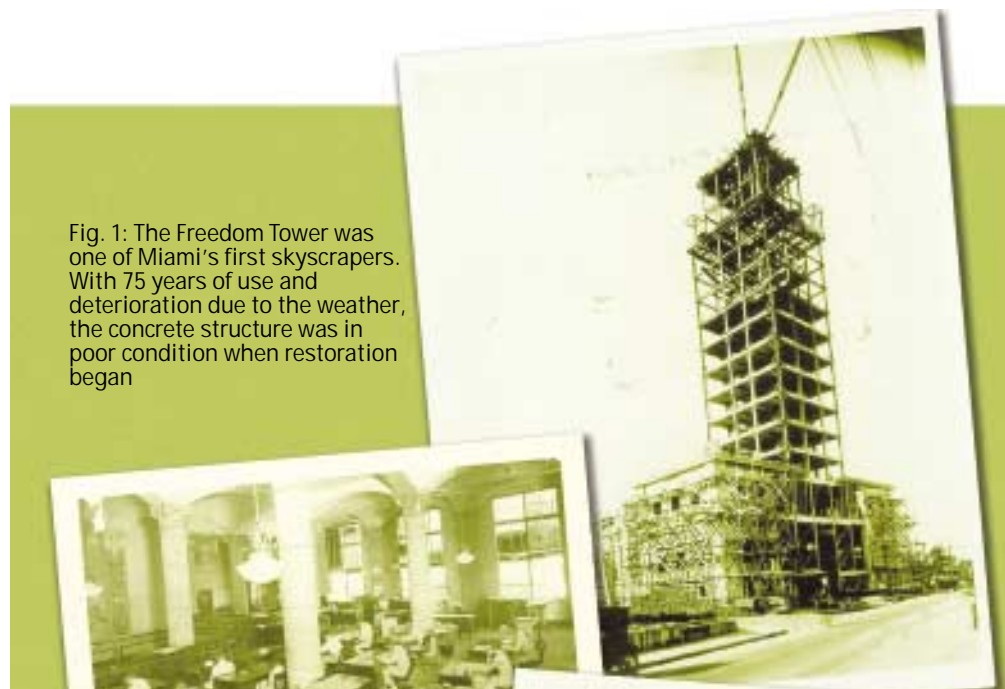
Fig. 1: The Freedom Tower was one of Miami's first skyscrapers. With 75 years of use and deterioration due to the weather, the concrete structure was in poor condition when restoration began

Far more was plaguing the Freedom Tower than mere aesthetics—the structure was crumbling from the inside out. From the moment of its birth, early, primitive concrete construction methods had sowed the seeds of destruction within the building’s own columns, beams, and soffits. An improper mixture of ingredients in the structural concrete had resulted in a high amount of cast-in chlorides, exacerbated by the prevailing saltwater air. The resulting delaminations, cracks, and spalled concrete created an environment that exposed the reinforcement to the elements, and corrosion began. The building was, in fact, well on its way to collapse.

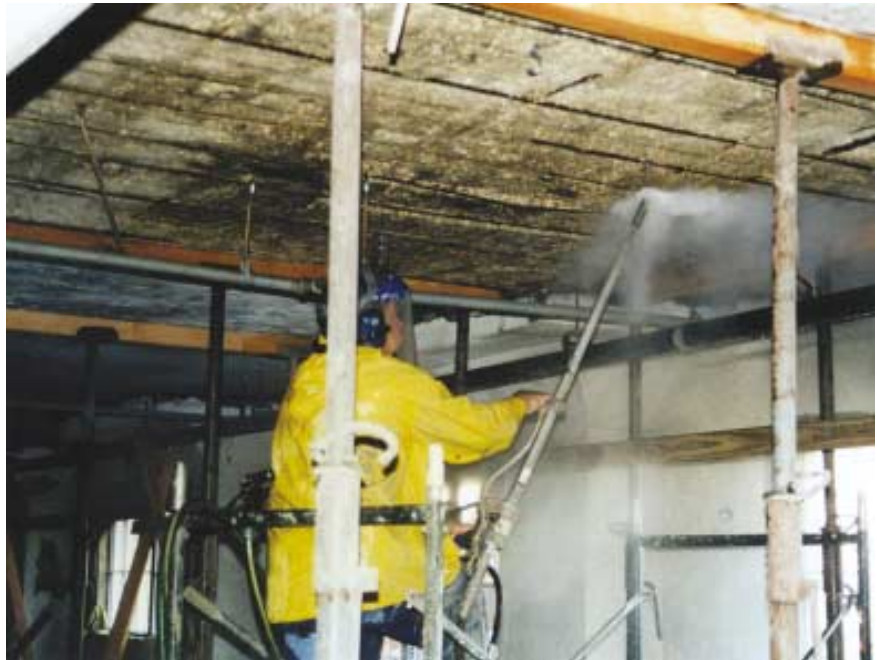
Overhead soffit conditions showed delamination, plus cracked and spalled concrete. Structural Preservation Systems used hydrodemolition to remove the delaminated and spalled concrete (Fig. 4). Following this, detailed chipping of the concrete around the existing reinforcement steel created a minimum 3/4-in. (18 mm) clearance. This provided increased bonding capacity between the existing substrate and the new, added repair material. (It also allowed the repair material to consolidate around the bars.)

Fig. 4: Removal of delaminated and spalled concrete by hydrodemolition

Next came cleaning and surface preparation, with sandblasting or abrasive blast cleaning to remove all rust and corrosion from the reinforcement steel. Because some of the corrosion was so extensive, work crews replaced 50% of the reinforcing bars, according to Sommer.

The repair process continued with construction of the formwork for the form-and-pump placement of new concrete. After formwork erection, the repair material was pumped into the forms. A compressive strength of 6000 psi (40 MPa) was achieved after a 28-day cure. According to Sommer, the soffit repair procedure included adding approximately 1 in. (25 mm) of extra structural concrete to the original construction. "We removed three inches, and put back four," he notes.

Because such a large area of overhead repairs was required (more than 6000 ft² [560 m²]), the work was conducted in a phased manner using a "checkerboard" pattern, so as not to compromise the structural integrity of the slab at any time during the repair procedure. Repairs were completed in each section before moving on. "It was much more time-consuming to complete the work this way," Sommer says, "but otherwise the structural integrity of the slab would have been jeopardized."

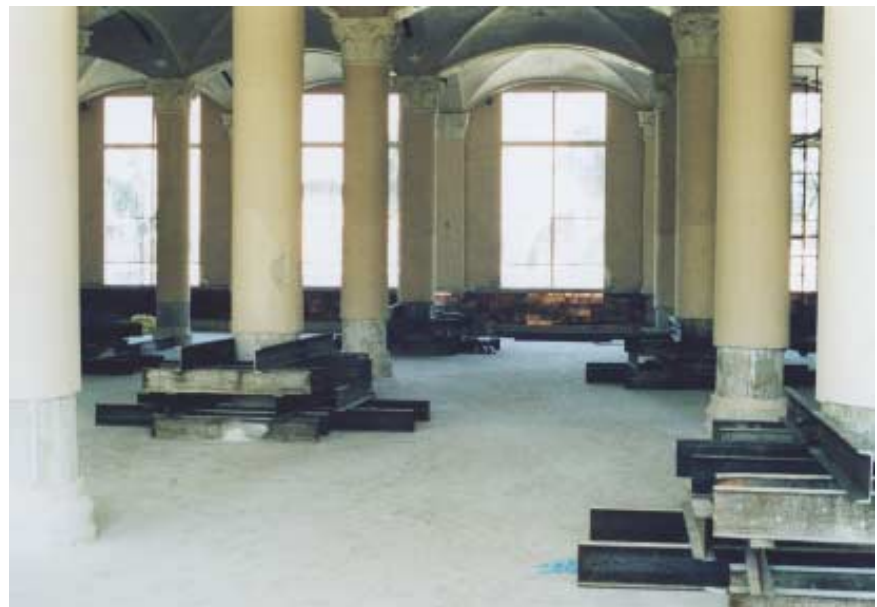
Structural inspection of the columns uncovered similar problems, requiring form-and-pump repair procedures that turned out to be anything but ordinary. The Freedom Tower job was challenging, requiring extensive shoring of the upper floors and pinning of the whole shoring assembly to the columns above (Fig. 5).

Fig. 5: Unique shoring design to transfer the load of the columns below

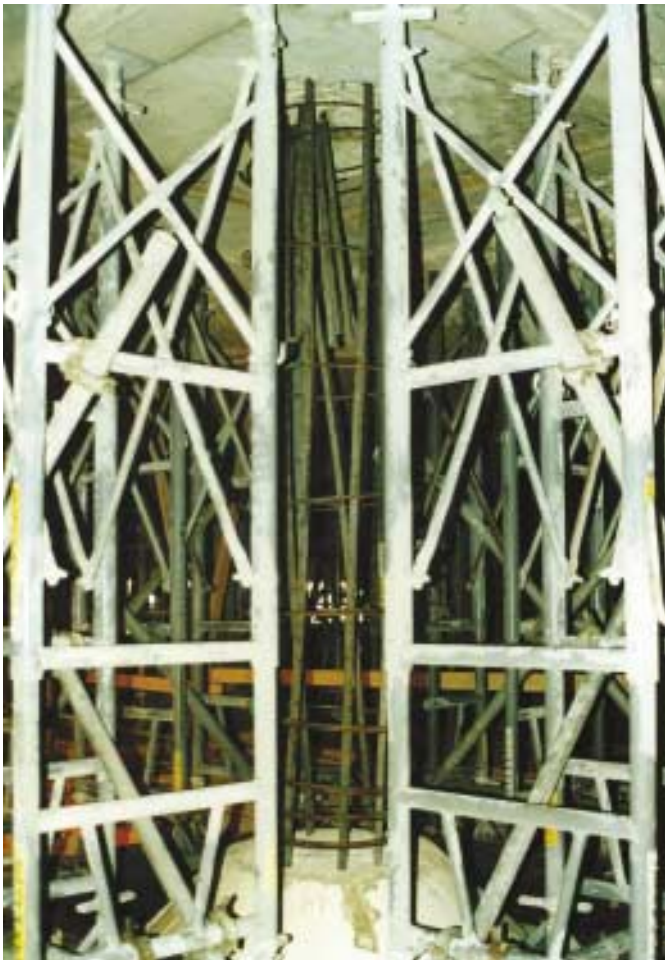
Because of their years of exposure to the elements—coupled with the loads they had carried over that time—many of the 24-in.-diameter (600 mm) columns in the ground floor garage area required full-depth repairs (Fig. 6). In addition to abrasive blast

Fig. 6: Complete column demolition and shoring at the first floor

cleaning to remove rust and corrosion from the reinforcement steel, hoop stirrups were added to provide additional reinforcement to the column members. A water-based curing compound was then applied, and the top 4 in. (100 mm) of each column dry-packed using a nonshrink grout.
